# Low Temperature Top Seal for the LAPPD Project

Argonne National Laboratory

University of Illinois - Chicago

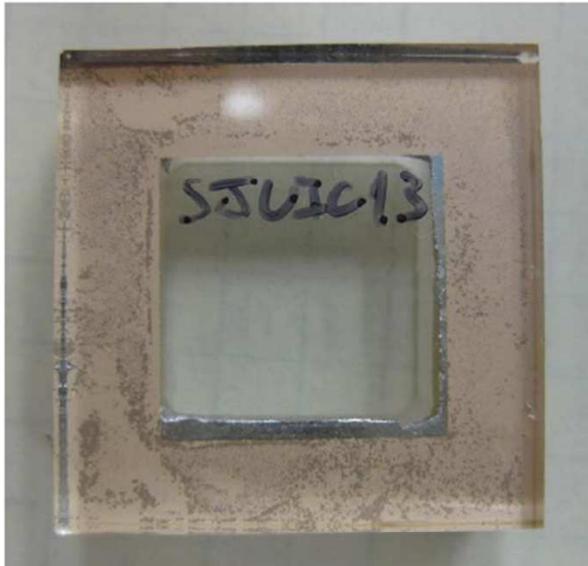
## Appearance of Silver Layer

- 66In/34Bi
- Formation of discolored patches at silver-glass interface.
- Intermetallics? Oxides?

- Samples with NiCr coatings had better leak test results than those with Ag layers.
- 66In/34Bi foil produced more discolored patches than 52In/48Sn at the silver paste layer-glass interface.
  - The composition and relevance of these patches are not yet determined
- Samples will be leak checked again in the future to determine effects of aging.

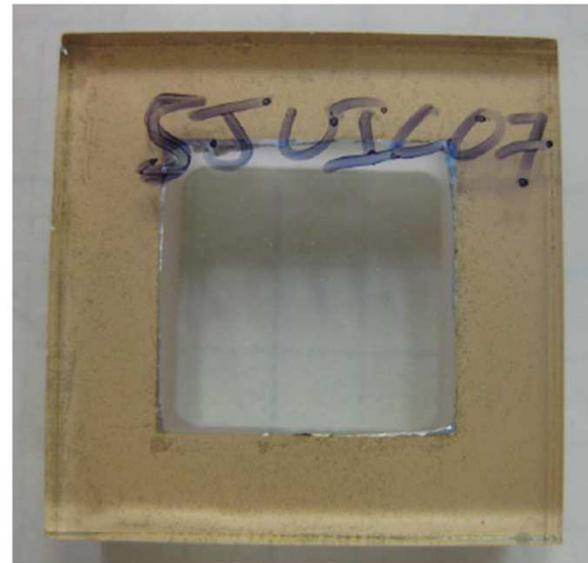
- 52In/48Sn
- Lesser formation of discolored patches.
- Intermetallics? Oxides?

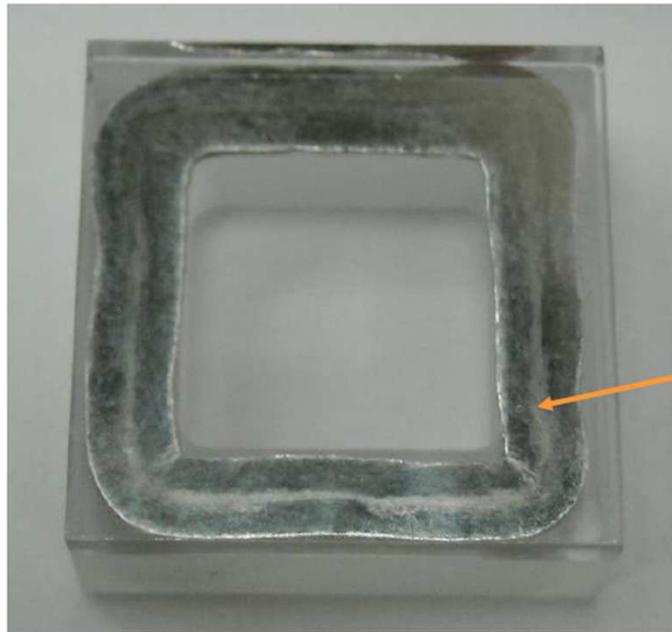
- Plastic deformation is key
- 100%In wire - 0.030" D

Area of indium oxide showing the original location of the wire.

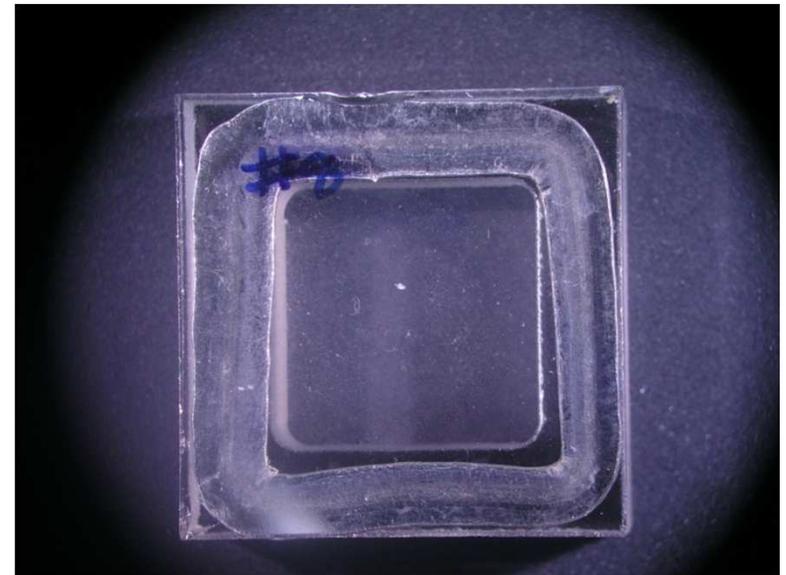
- With a loading of 800 lbs, seals have been made between both glass and NiCr coated glass substrates.
- The seal filler was pure indium in the form of .062" diameter wire
- These seals were made in air.
- All the parts were cleaned in acetone and alcohol.
- At loads of 600 lbs and lower the joint between the ends of the wire became a problem.
  - Although there is evidence that a seal was made at loads as low as 300 lbs .

800 lbs – 100 In – 20°C – 1 minute

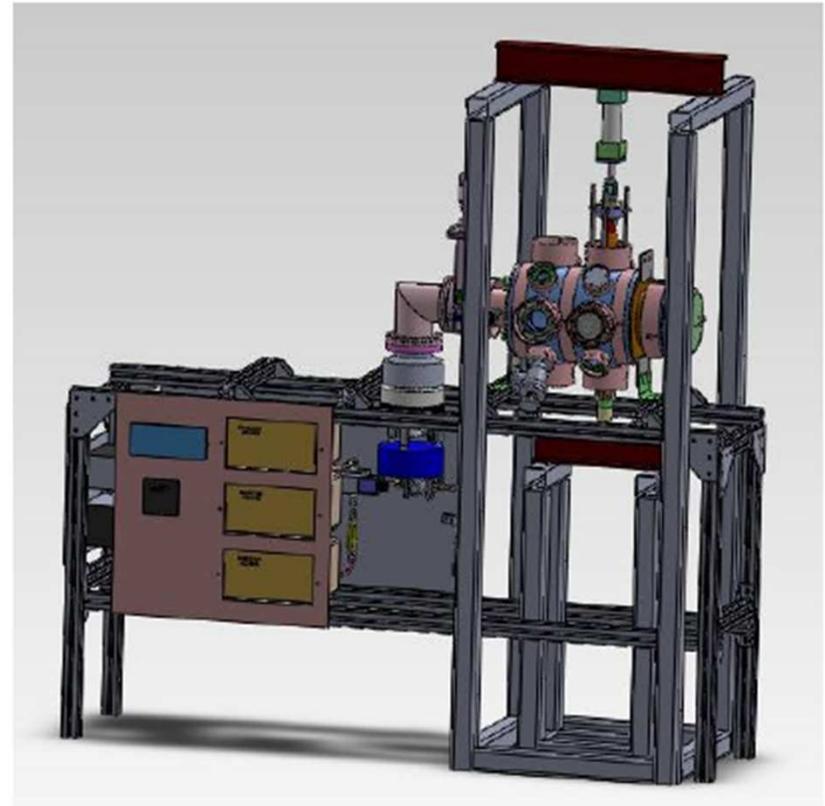
- Low Temperature Bonding System
  - Now operational for heating
    - Heating controls completed by HEP Electronics
    - Infrared lamps operational in the system.
  - Vacuum system
    - System leak tight
    - Base pressure of the system is  $3 \times 10^{-8}$  torr.
  - Hydraulics
    - Last parts being completed in shops
    - Hydraulic manifold leak tight and ready to move onto the system.

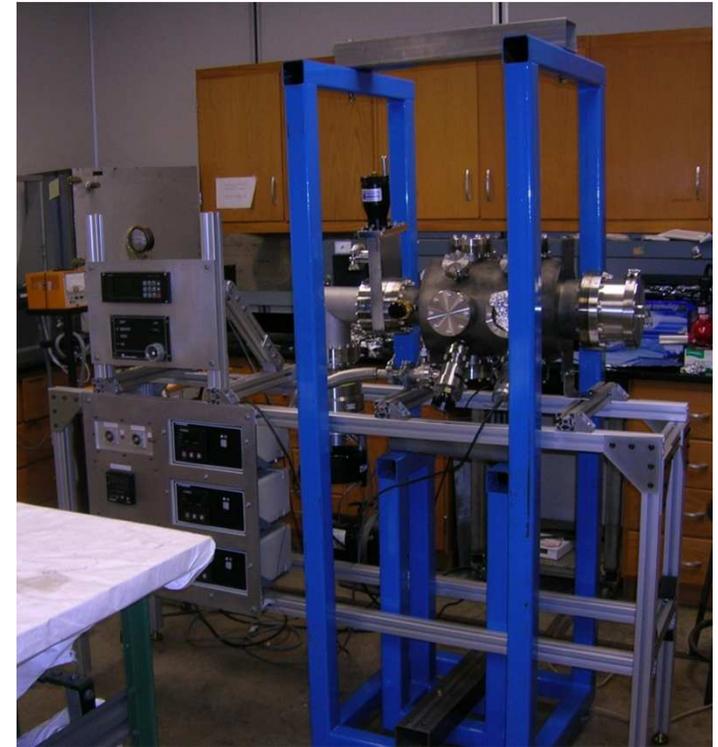
- Continue to pursue the soldering method
  - The system above has a heating capability to perform soldering in vacuum
- Fab samples that do not use flat surface to compress the seal, these samples will use beveled edges. It will be investigated that by applying the load in a small area improves the seal performance.
